SAFETY STUDY 1/2001

**REVIEW OF
LIFEBOAT AND LAUNCHING SYSTEMS'
ACCIDENTS**

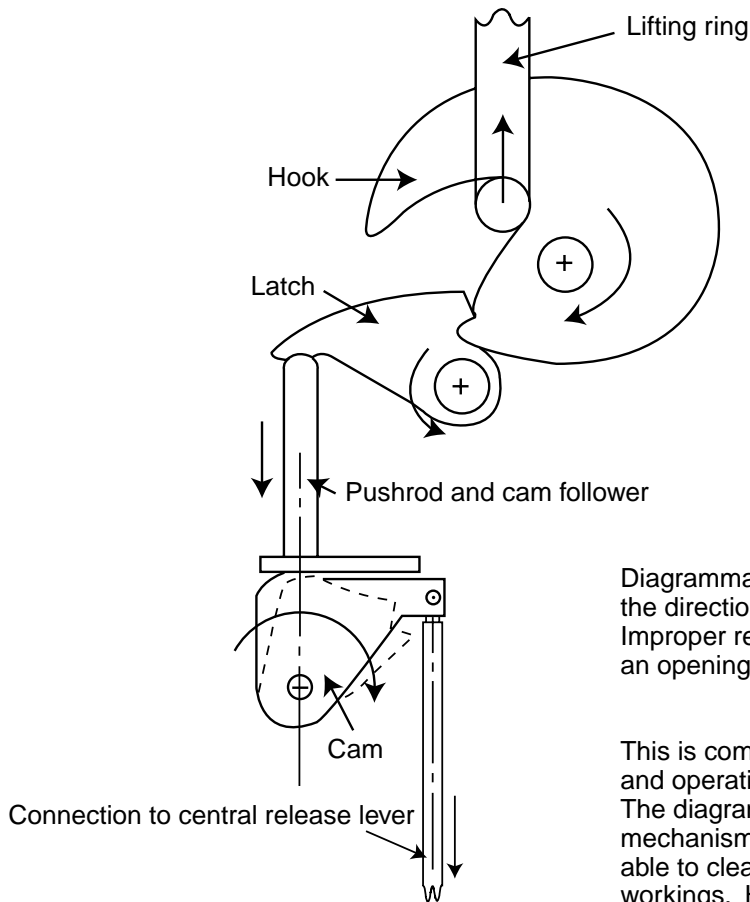
Figure 1

It has been found that crews generally have a poor understanding of the operating principles involved with release hooks, often because of inadequate training. This is not the only reason. Poor labelling, complex mechanisms and hard to follow operating instructions in some manufacturers' manuals have also featured as contributing factors **(see Figure 1)**.

Diagrammatic arrangement of hook release mechanism and the direction of movement of its components during release. Improper resetting of the cam, as shown dotted, can induce an opening moment leading to inadvertent release.

This is compounded by the complexity of the mechanism and operating instructions that are difficult to understand. The diagram, showing the important features of resetting the mechanism, is complicated and makes it necessary to be able to clearly see the actual mechanism to understand its workings. However, viewing the mechanism is difficult, making understanding of the diagram difficult. Other material in the manufacturer's instruction manual was of little help in this task.

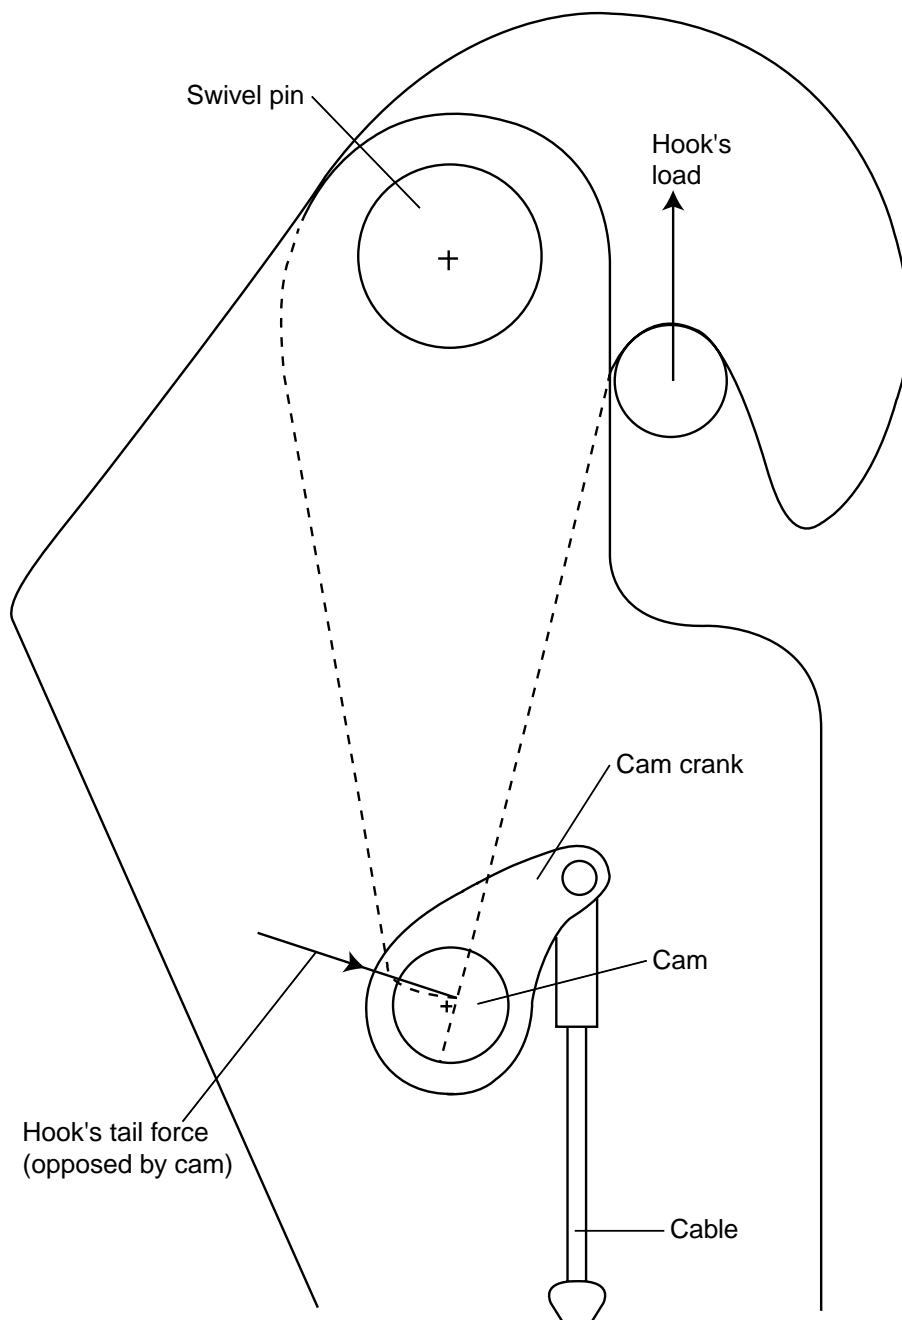
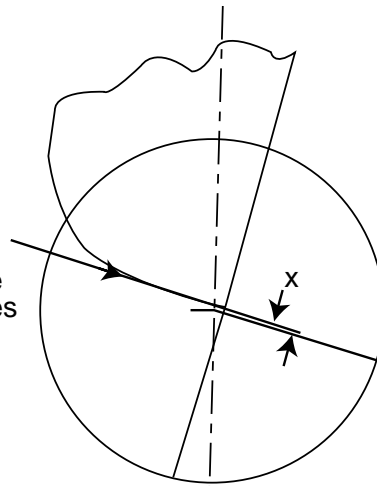
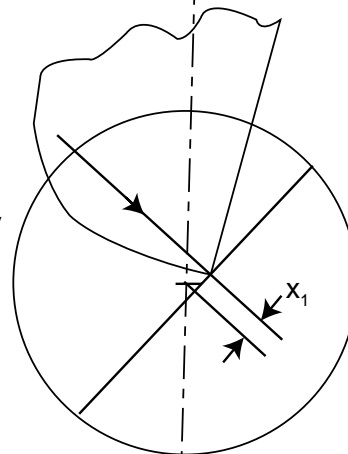
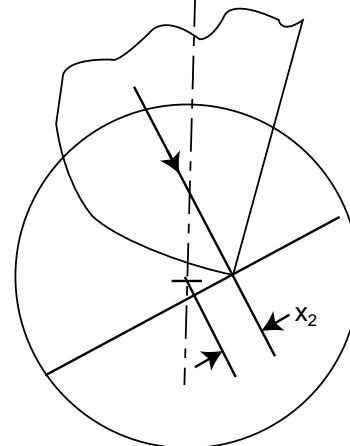
Figure 2

Analysis of a number of accidents reveals that premature hook release has often been caused by the failure to re-set it correctly when the lifeboat was being recovered from its previous launching. This shortcoming stems from a lack of understanding of the mechanism involved, inadequate training and poor maintenance. Once the hook has been incorrectly reset, spontaneous release is possible at any time before the lifeboat is next put in the water **(see Figures 2 and 3)**.

Hook and cam in fully closed position. Flat face of cam and tail of hook are in contact. This gives the minimum lever 'x' by which the force from the hook's tail generates an opening moment on the cam. This moment is resisted by the moment generated by the cable force.

Partially closed condition. Improper resetting of the cam when a boat is being recovered might generate this state. Can be aggravated by sticky cables. The size of the lever ' x_1 ' is much greater than that for the fully closed position ' x '. This allows the force from the hook's tail to generate a much larger opening moment on the cam. It is possible for this moment to overcome that generated by the cable leading to rotation of the cam and spontaneous opening of the hook.

Further rotation of the cam leads to increase in the size of the lever to ' x_2 '. The moment generated on the cam is so large that it will almost certainly overcome the moment generated by the cable force. The hook is then able to fully open.

The above sequence shows the magnification in hook opening effects due only to the growth in lever of the force in the hook's tail. Other changes take place as the cam's face rotates, which result in an increase in magnitude of the hook's tail force and thus also the cam rotating moment. All of these effects indicate the importance of properly resetting the cam when recovering a boat.

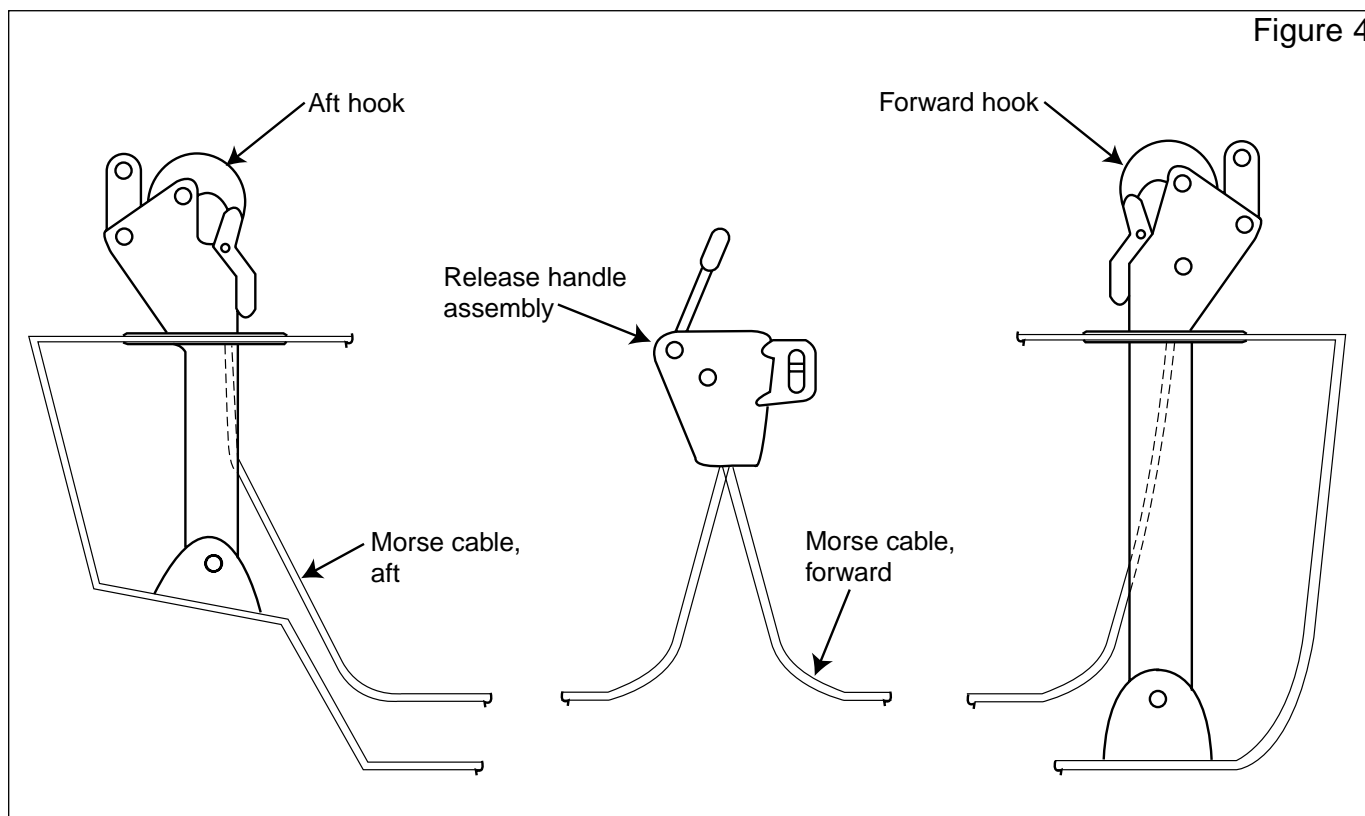
Figure 4

Operating cables

The MAIB has found, however, that these cables can seize if the stranded wire becomes corroded. This can result in the on-load release hook failing to close properly when being reset. This in turn has resulted in inadvertent release later. Once corroded these cables cannot be repaired effectively, and have to be replaced. The evidence shows that management and crews are often unaware that such replacement is necessary.

In response to one MAIB recommendation, a manufacturer amended its on-load release hook operation and maintenance manual to emphasise the importance of replacing damaged or corroded cables. It is not always the case. It is known that some other manufacturers do not draw attention to the inherent dangers of not replacing corroded cable.

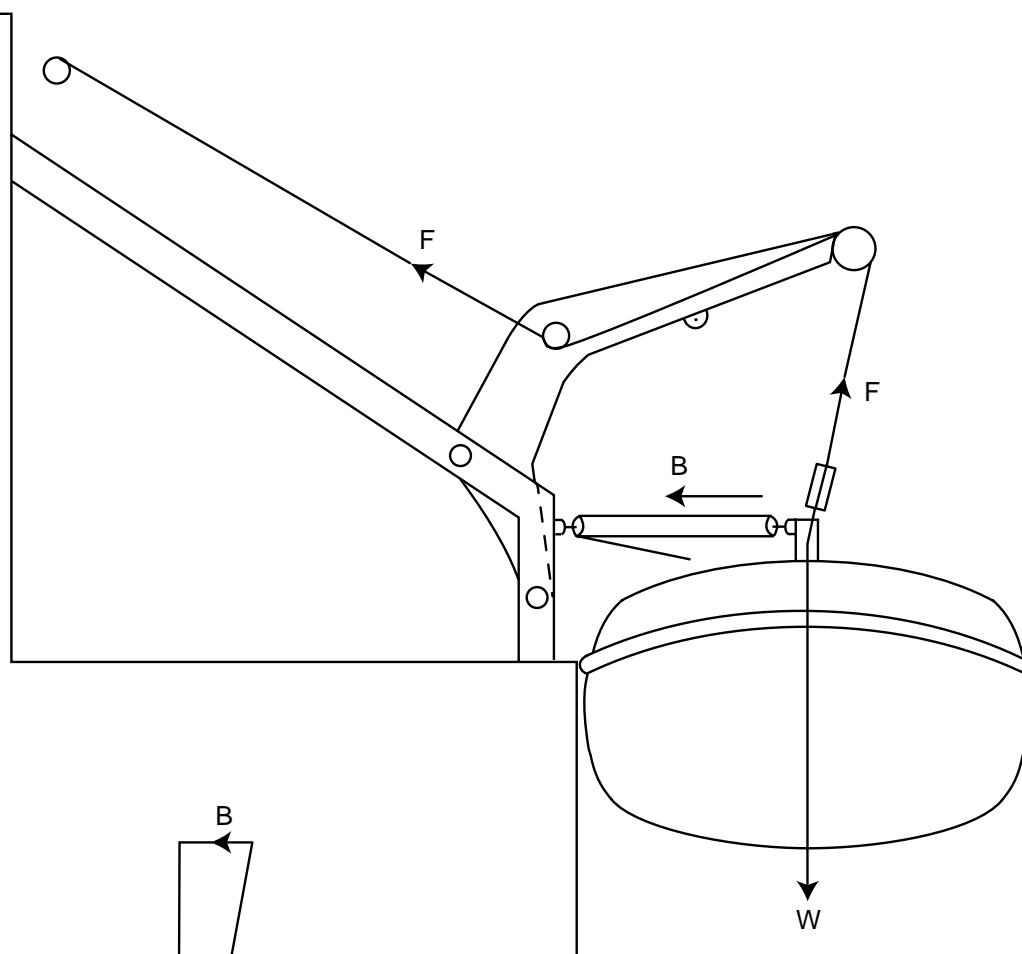
Figure 6

Lifeboat lowered to embarkation level, triced in and the bowsing tackles fitted. Once tricing pendants are slipped, properly tensioned bowsing tackles retain the lifeboat into the ship's side. Because the bowsing forces are virtually horizontal, only the falls load (F) supports weight (W), as intended. Also, F is acting in the back falls and contributes to the support of the davit arms.

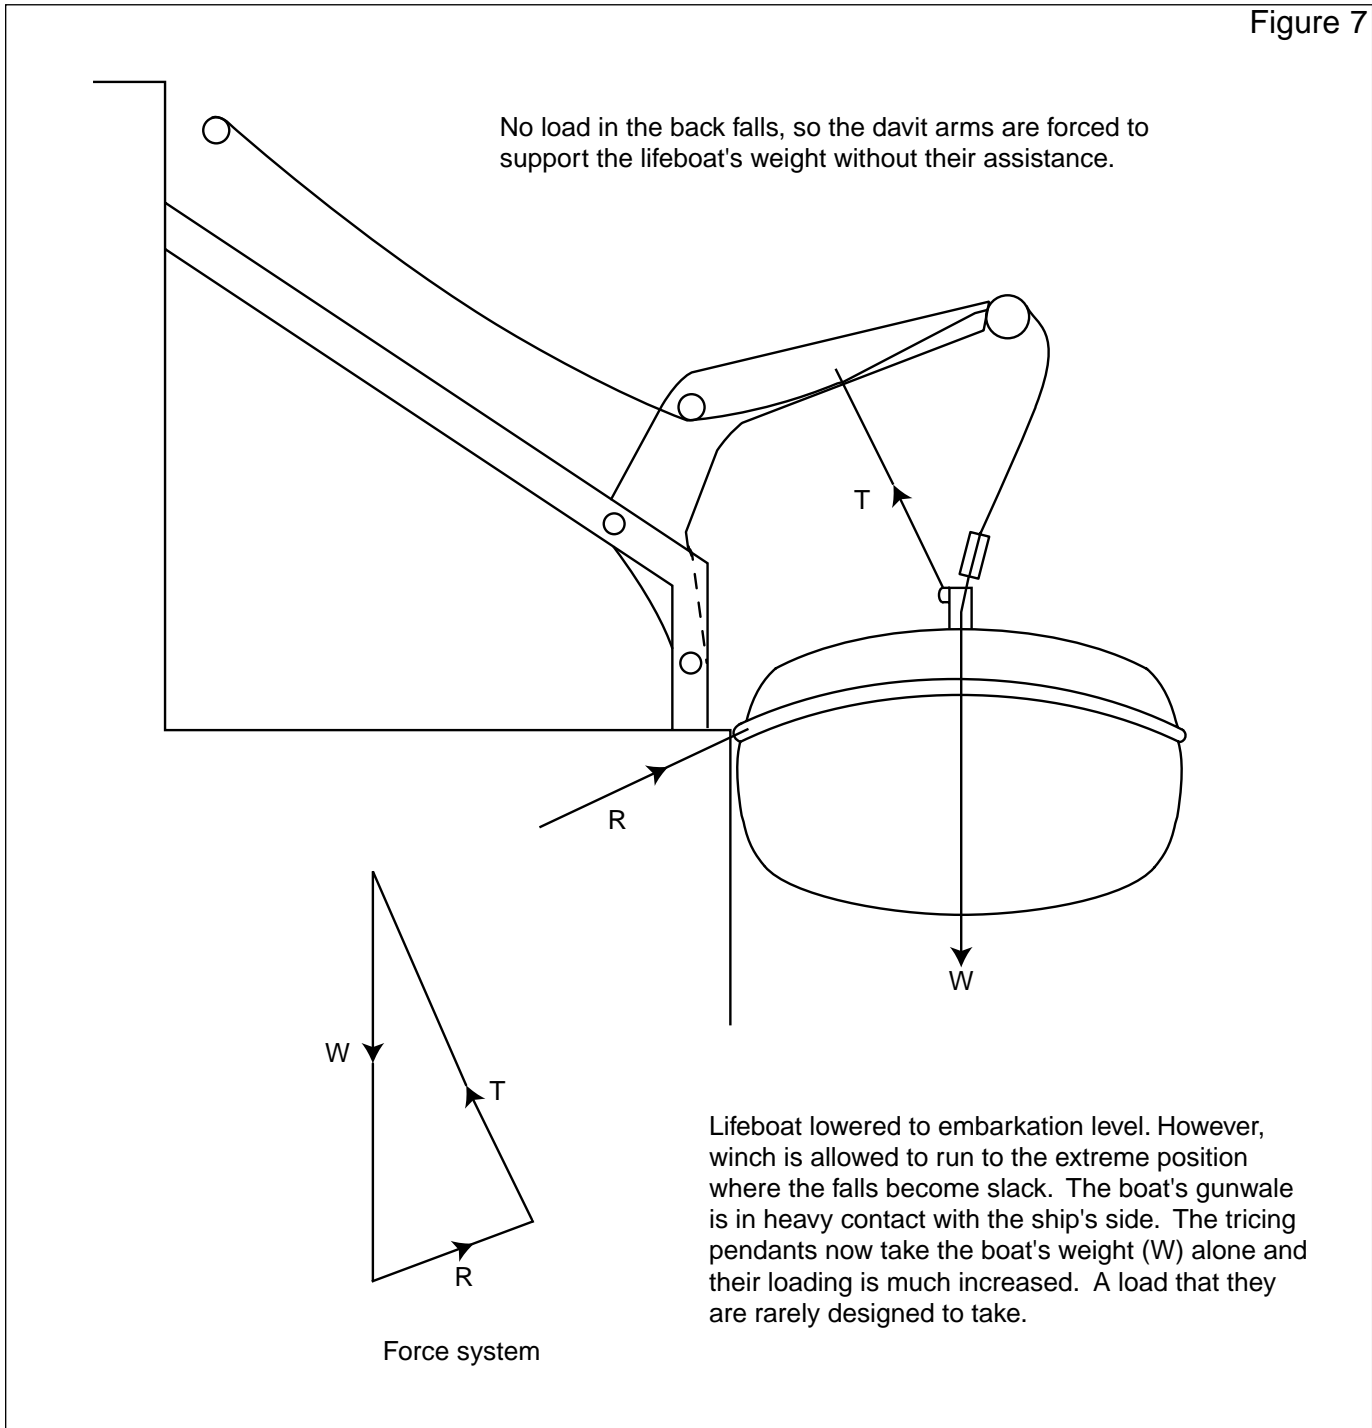
Figure 7

A second potential danger of not bowsing in a lifeboat is that a loaded lifeboat might overload the tricing pennants. If they fail (**see Figure 7**), the consequences can be serious. This is likely to occur if the lifeboat is brought hard against the ship's side. It can even lead to the falls going slack if the winch wire is paid out too far. Tricing pennant failure would again cause the boat to swing uncontrollably, endangering anyone who happened to be embarking at that particular moment.

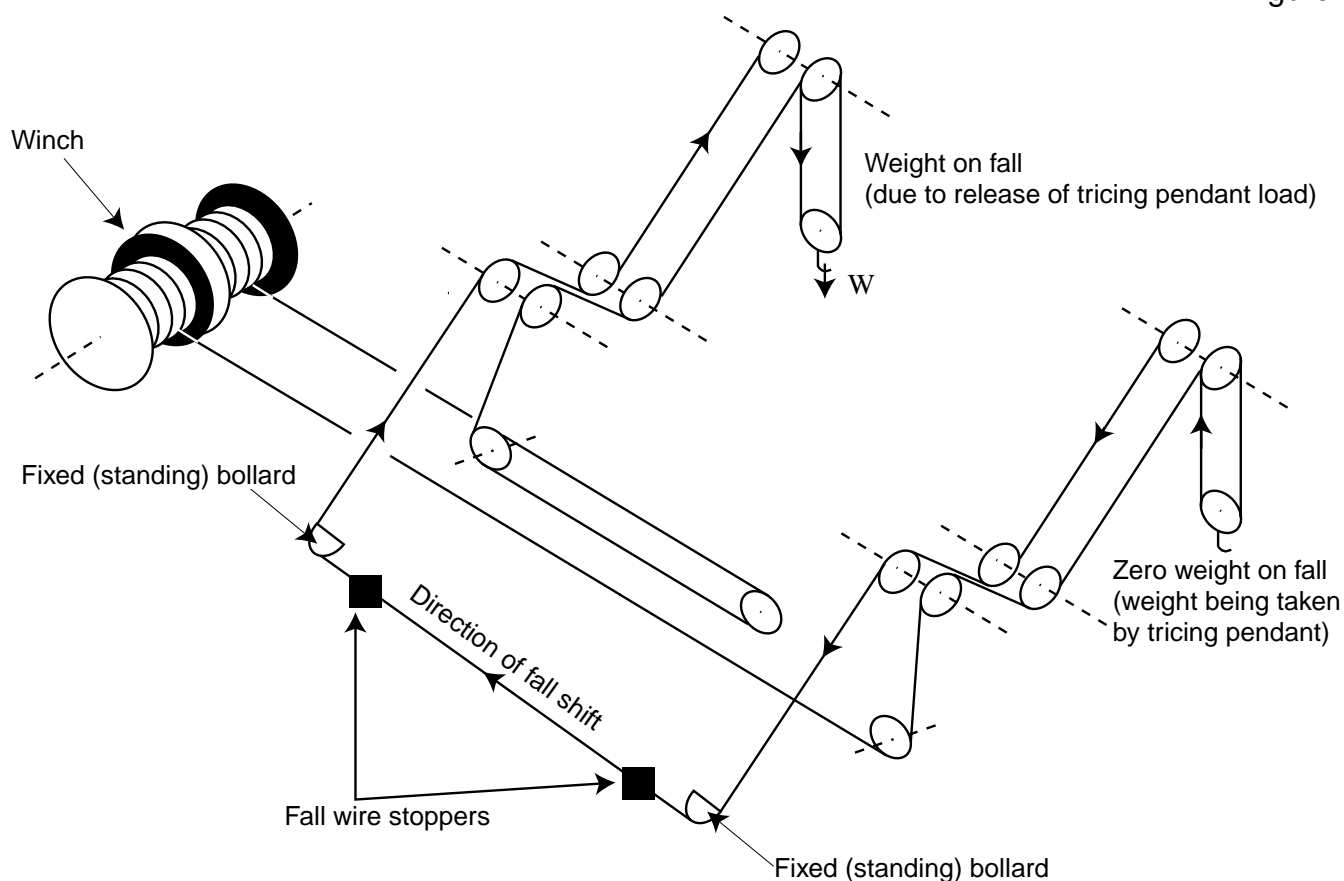
Figure 8

Failure of a single tricing pennant with slack falls has been known to have serious implications. When continuous falls are fitted, they will run out at the end where the failure has occurred. The lower block at the other end will simultaneously rise, sometimes sufficiently far and hard to hit the head of the davit arm. This imposes a dynamic overload on it and may lead to failure with the consequential repercussions for anyone in the lifeboat. This seemingly unlikely train of events has occurred in one boat where the crew was testing experimental tricing/bowsing gear (**see Figure 8**). It was a serious accident and people were killed.

When lowering the boat to embarkation level, the winch might be payed out so far that the falls go slack. Only the tricing pendants then take the boat's weight. Should one tricing pendant then fail, or is slipped, the weight at that end attempts to transfer to the falls. However, as there is no weight on the falls at the other end, because the remaining tricing pendant is still taking it, they can offer no balancing reaction. They then have a tendency to shift or slide towards the end where the tricing pendant has failed. This tendency is normally resisted by friction between the falls and the standing bollards. But, again, without load in the falls no significant friction force can be generated.

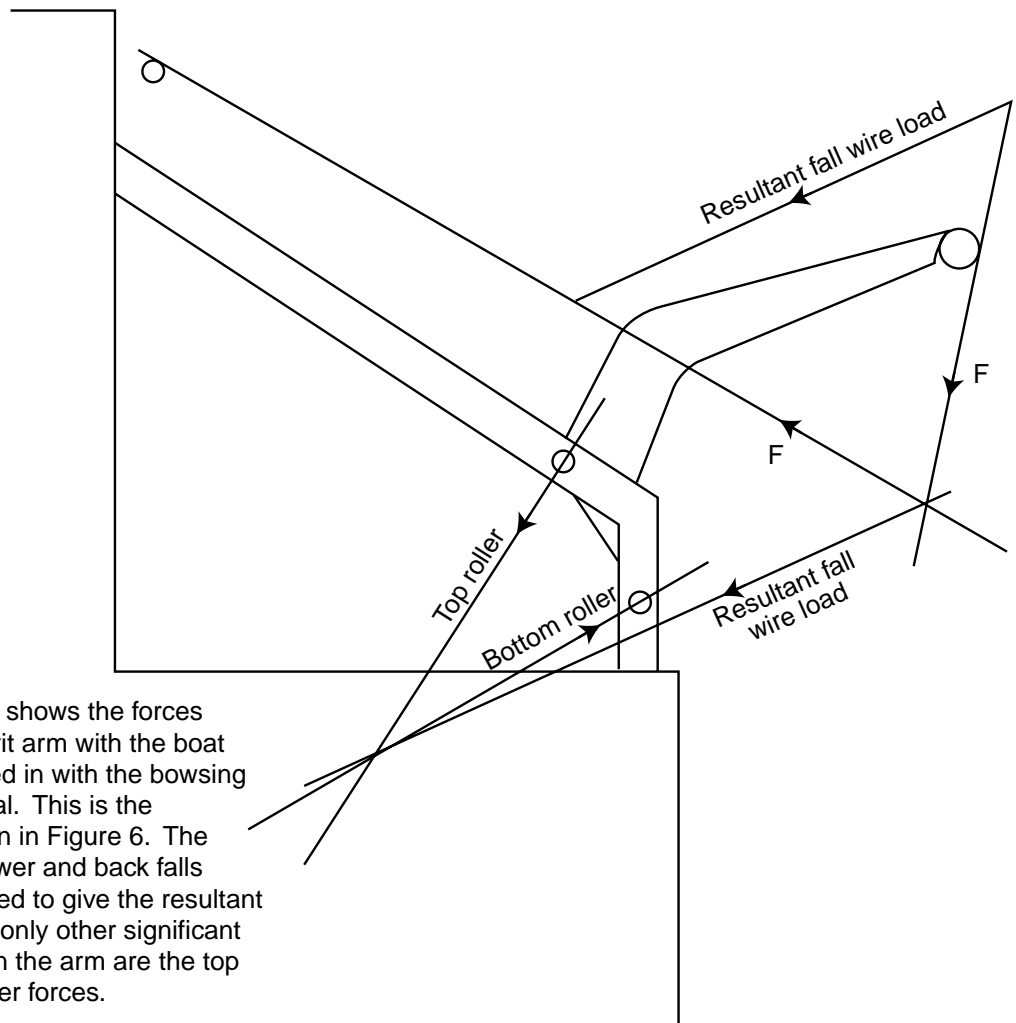
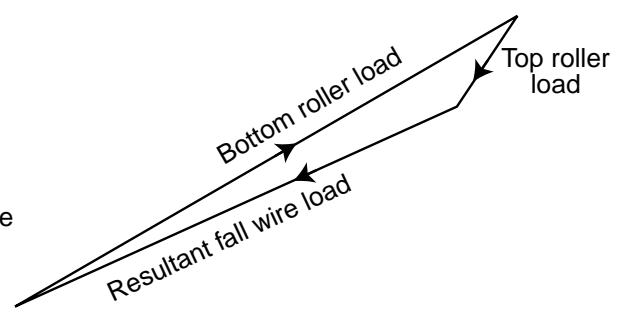
Figure 9

Above diagram shows the forces acting on a davit arm with the boat properly bowsed in with the bowsing tackle horizontal. This is the condition shown in Figure 6. The forces in the lower and back falls have been added to give the resultant wire load. The only other significant forces acting on the arm are the top and bottom roller forces.

The diagram to the right is the above force system giving the relative magnitudes of the forces.

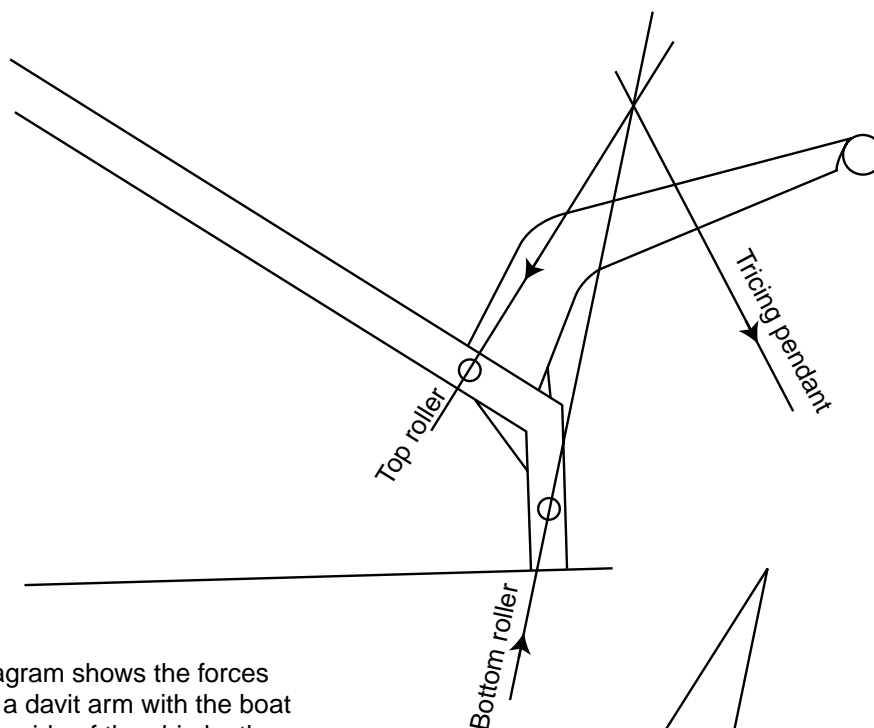
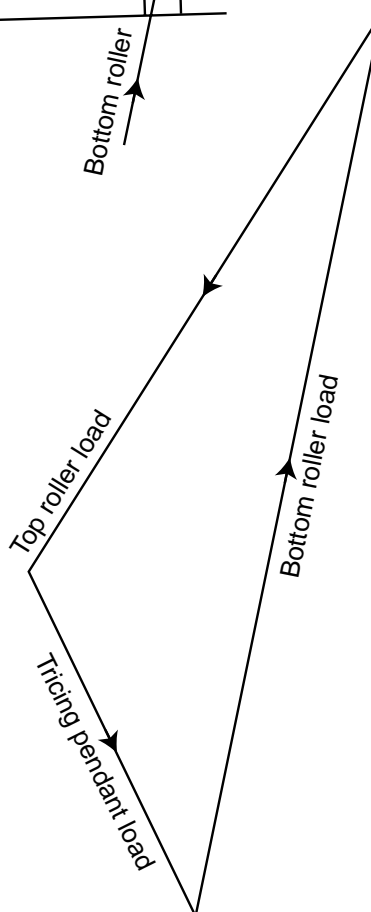
A further consequence of not properly bowing in a lifeboat can occur if the load bearing capacity of the davit arms is dependent on support offered by the back falls which lead inboard from the davit heads (**see Figure 9**). With the lifeboat at embarkation level, and supported by falls and tricing pennants, its weight is shared between them. The greater the proportion of weight taken by the tricing pennants, the less will be taken by the falls. This gives a corresponding reduction in the load on the back falls, which means that their contribution to supporting the davit arm is reduced. This results in an increased portion of the load being taken on the supporting structure of the davit arm and can, on some designs, overload it if the boat is fully laden (**see Figure 10**).

Above diagram shows the forces acting on a davit arm with the boat held to the side of the ship by the tricing pendants and with the falls slack. This is the condition shown in Figure 7. The only significant forces acting on the arm are the tricing pendant load, the top and bottom roller forces.

The diagram to the right is the above force system giving the relative magnitudes of the forces. Notice how much greater are the roller loads compared to the properly bowed in condition of Figure 9.

This critical feature has led to one total failure of a davit arm during an overload test. The surveyor failed to recognise the contribution made to the davit arm's support by the back fall load. He agreed to the test load being supported directly from the davit head, rather than being applied to the hook and lower block. On application of the test load, the davit arm was torn from its trackway. Fortunately since it was a test, nobody was in a position to be injured, but it demonstrates how important the support of the back falls load can be in some designs.

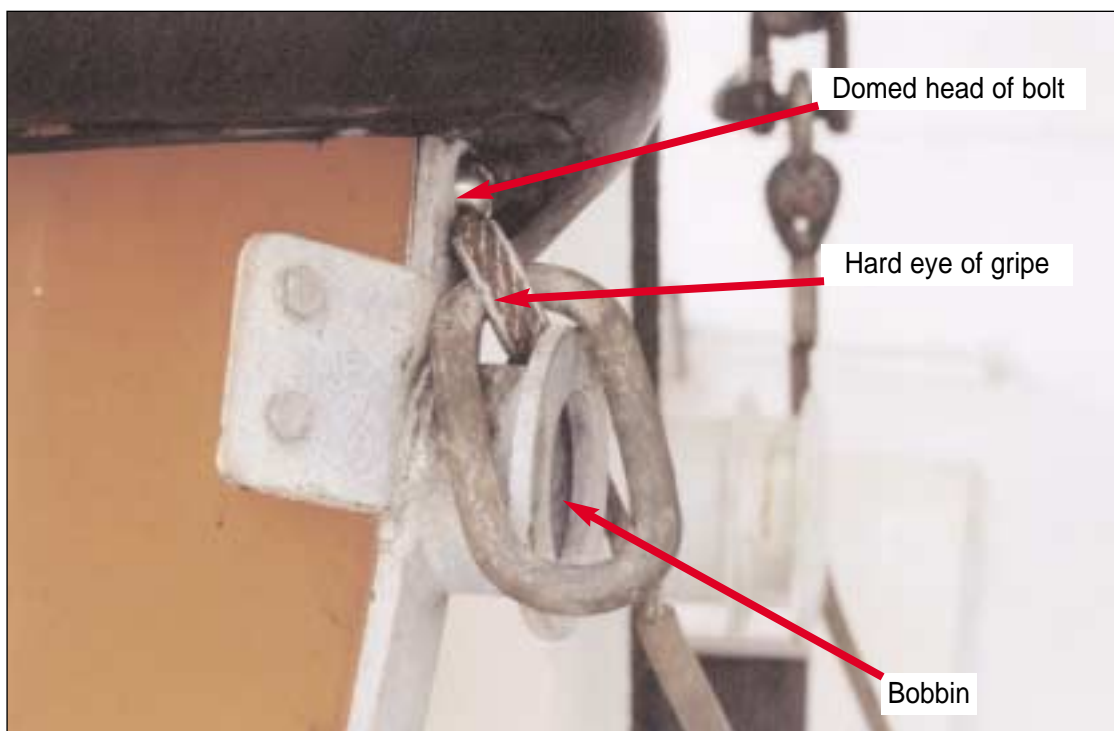
Figure 11

The MAIB received one report where the hard eye on the freed end of a gripe fouled the gripe's bobbin and the domed head of a mounting bolt (**see Figure 11**). This happened during the early stages of lowering. Fortunately it happened during an exercise where there was someone available on the vessel to free the gripe. Had this occurred in different circumstances, the lifeboat could have been loaded, lowered clear of its davits, and yet been prevented both from being lowered to the water and raised under control of the people in the lifeboat. Changing the size of the hard eye allowed the gripe to slide freely over the bobbing and cured the problem.

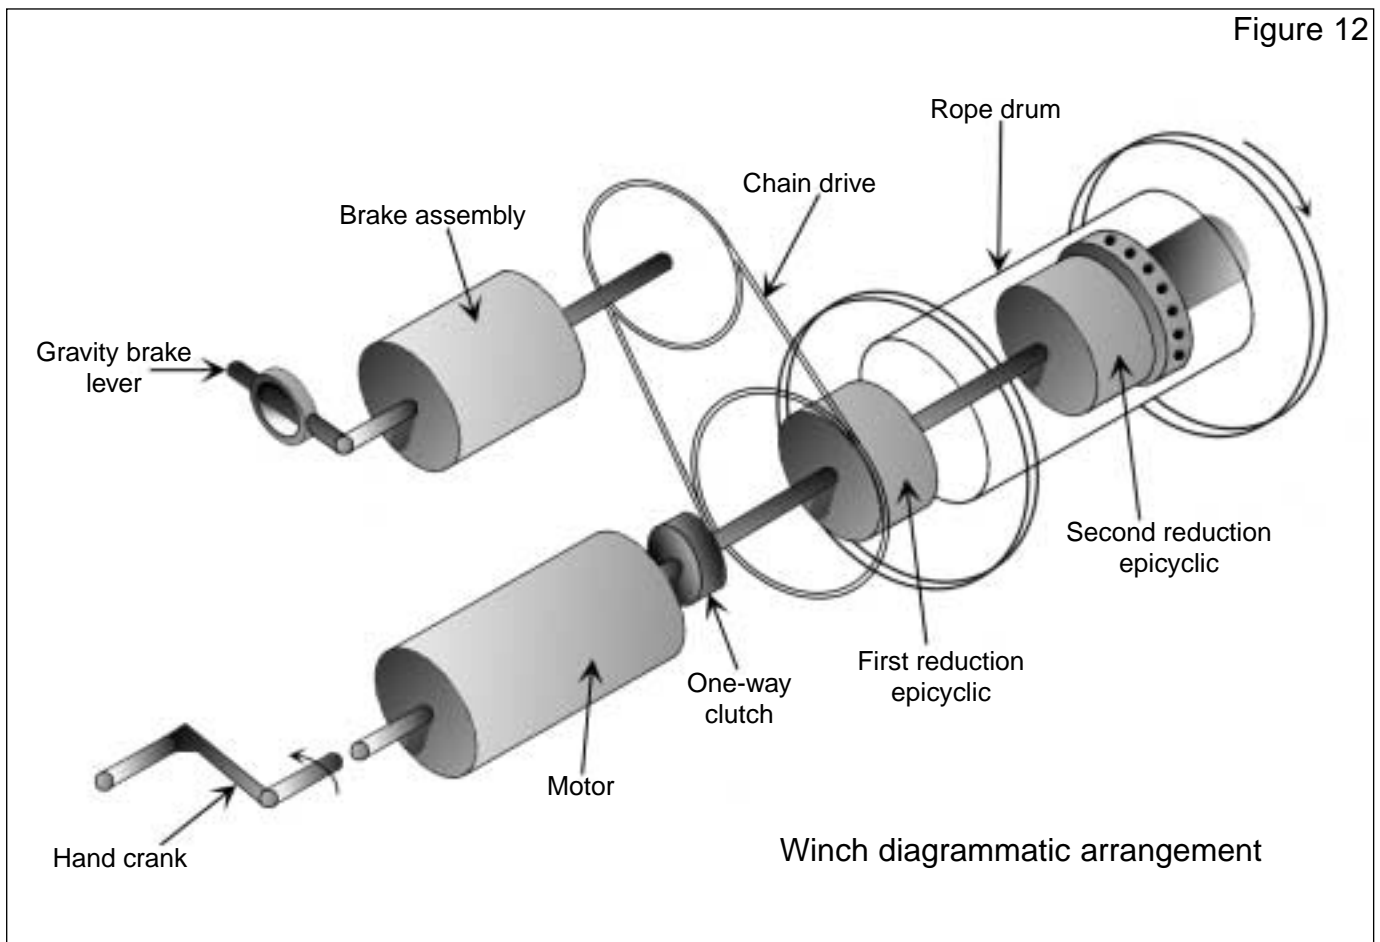
Figure 12

During the 1960s several new designs of winches were submitted to the UK Administration for approval. Some employed one-way sprag-type clutches. These used smooth inner and outer tracks, and relied entirely on friction forces to lock the unit. Carefully shaped spring-loaded sprags within the annular space between the tracks, generated the locking forces. These units ran free when one half of the unit turned, and locked when opposite rotation was applied.

Some of these one-way clutches have failed in service. In such circumstances a lifeboat can lower uncontrollably and in some conditions, such as having bowing or tricing gear connected, it can tilt. The consequences for any occupants are likely to be serious.

Clutch failure can also lead to the lifeboat descending with neither the centrifugal nor manual brakes having any effect. Such failures have been found to occur immediately the hoisting motor has been stopped, when stowing the lifeboat, or when adjusting its position at embarkation level using the motor. The clutch is unable to re-lock after having run in the freewheel direction.
