Guidelines for the Prevention of Human Error Aboard Ships

Through the Ergonomic Design of Marine Machinery Systems

March 2010

NIPPON KAIJI KYOKAI

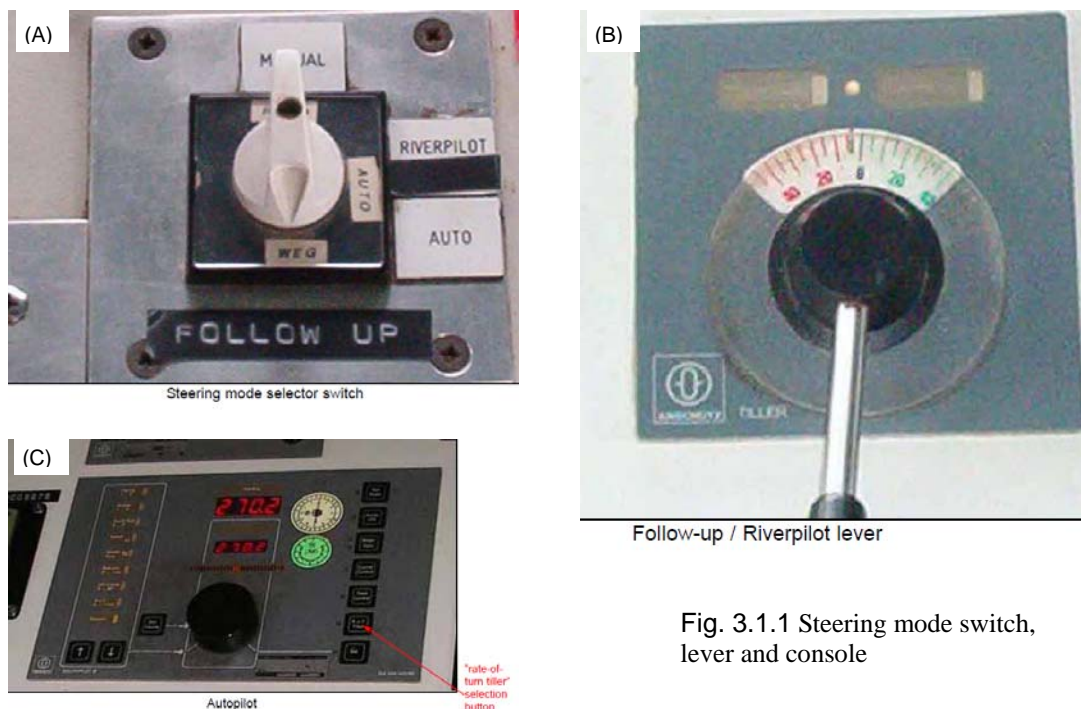
Fig. 3.1.1 Steering mode switch, lever and console

Although the operation of the RIVERPILOT mode was understood by both the pilot and the master, and it was one of the steering modes being used, the indication on the switch position display label shown in Fig. 3.1.1(A) was inadequate; a hand-made label had been affixed. Moreover, the hand-made label had been affixed incorrectly at the position of the AUTOPILOT mode; so even if the selector switch was turned in this direction, only the AUTOPILOT feature was available.

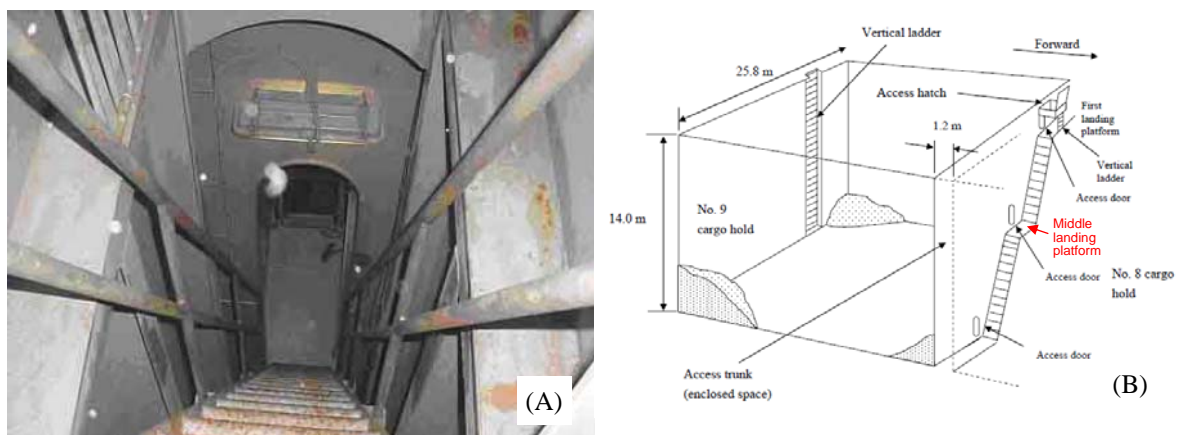
Fig. 3.2.1 Enclosed stair trunk and ladder landing platform

On 16 November 2006, a bulldozer was lowered into the hold to collect the remaining wood pallets at the end of the cargo hold so that they could be unloaded. While an ordinary seaman and a bulldozer operator were descending the enclosed stair trunk (Fig. 3.2.1(A)), the seaman collapsed at the floor of the cargo hold and the bulldozer operator collapsed at the middle landing platform (Fig. 3.2.1(B)) of the staircase. Both men collapsed because they were overcome by a lack of oxygen. The accident was soon discovered, and the two persons were rescued, but the end result was that the seaman died and the bulldozer operator was seriously injured in the incident.

As design measures, the following may be considered: (1) The material used for such signs should be able to withstand usage conditions, or its readability should be maintained by performing suitable maintenance (see ASTM F1166-07 15.1.11). (2) If there is any risk of overlooking signs, which may lead to significant danger, then signs should be put up at several locations so that information is properly conveyed.

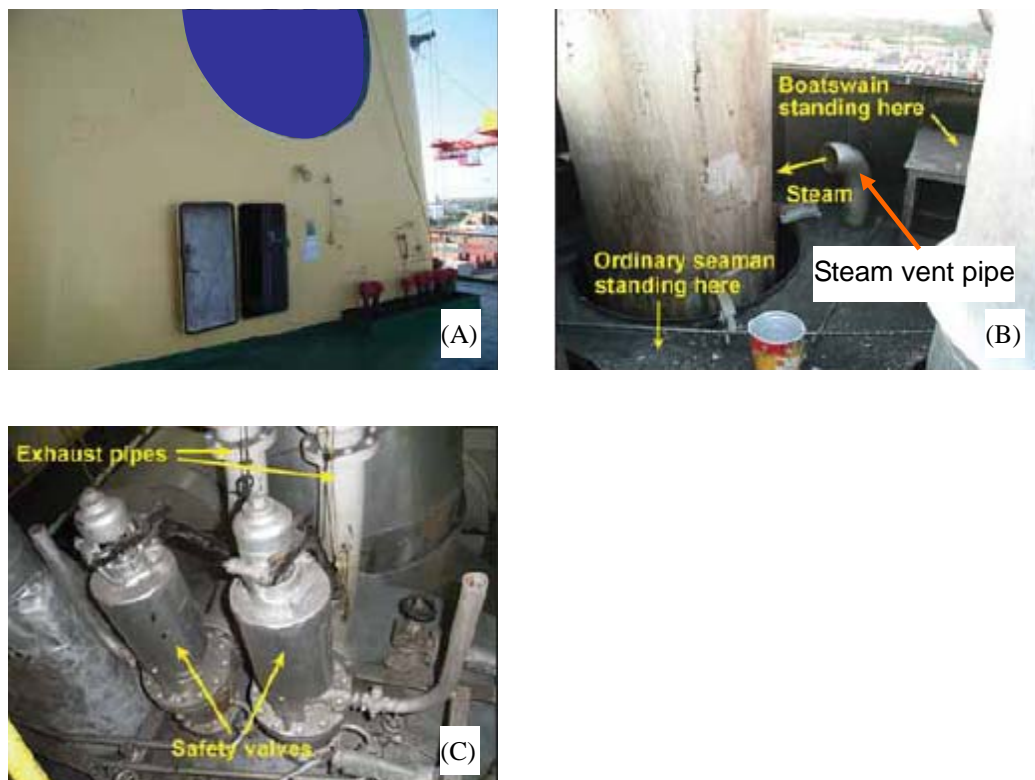
Fig. 3.3.1 Funnel, platform in funnel and boiler safety valves

On 10 April 2007, two crew members entered the funnel (Fig. 3.3.1(A)) of a container ship at anchor, went to the top platform (Fig. 3.3.1(B)) and started painting the main engine exhaust pipe in the funnel. Exactly at that time, an operating test of the boiler safety valve (Fig. 3.3.1(C)) was carried out for a classification society Boiler Survey, and steam was discharged from two safety valves for a duration of about 5 seconds at a pressure of 1.1 MPa. The result was that steam was directly discharged onto one of the crew members who suffered severe burns.

The two persons were aware of the risks of main engine exhaust, and had checked that the main engine was not working. However, they did not know that the pipe bent to 90 degrees and 0.5 m above the platform was a vent pipe of the boiler safety valve.

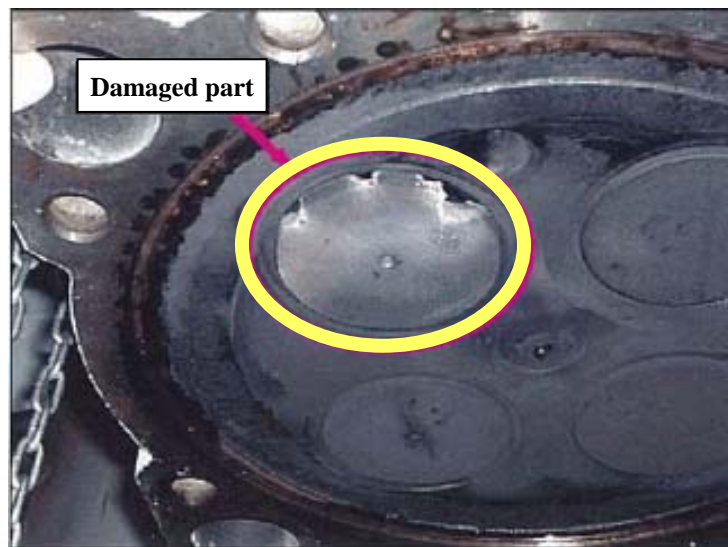
Fig. 3.4.1 Damaged valve seat of air inlet valve

During voyage, a rise in exhaust temperature and a drop in pressure in the No. 4 cylinder of diesel engine driving generator were found. The generator was stopped and inspected. The inspection showed that the intake valve had been incorrectly inserted on the exhaust valve side, and that the intake valve seat was damaged (Fig. 3.4.1).

The intake valve and exhaust valve have similar shape, and their sizes are almost the same. So, except for a slight difference in color due to the difference in materials used for each valve, it is difficult to differentiate the valves visually.

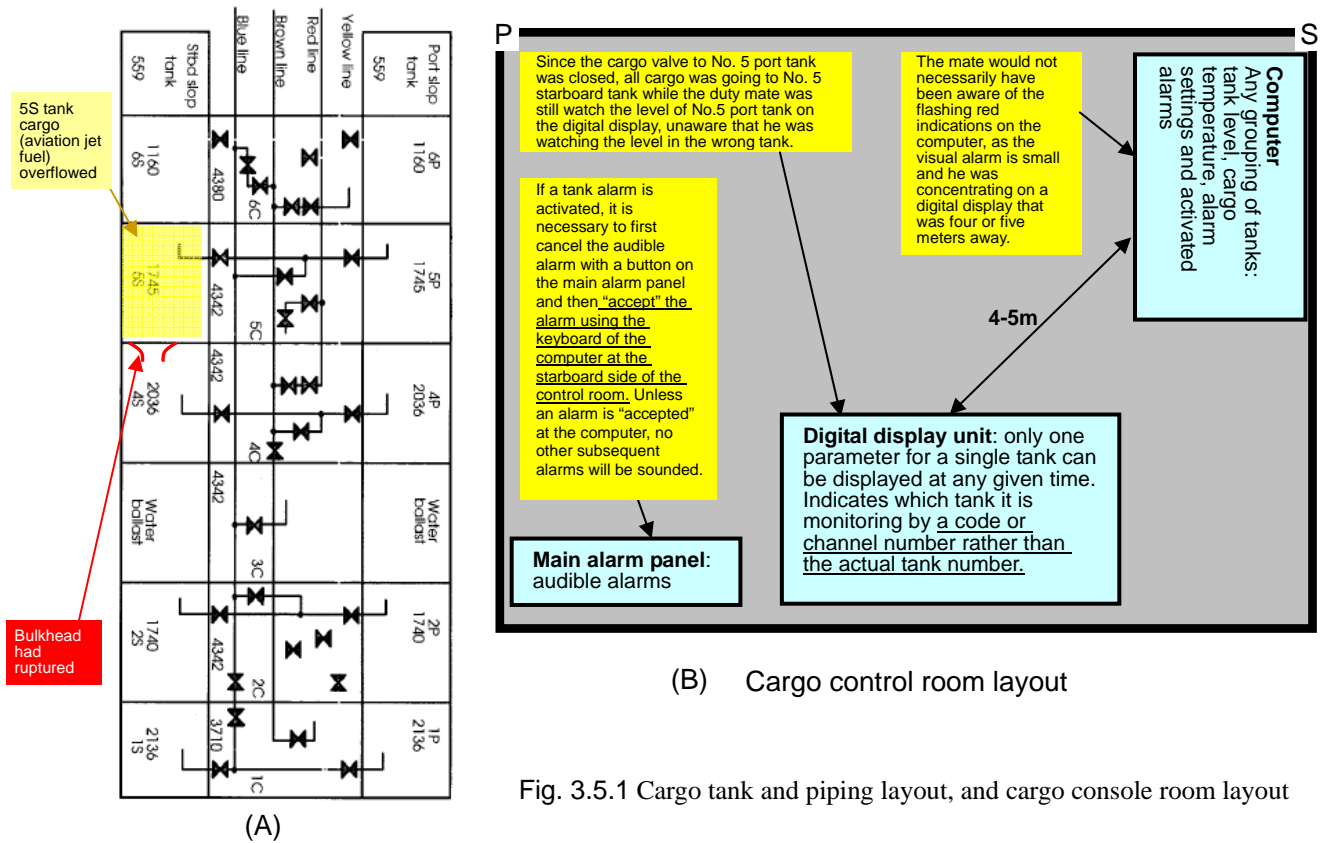
Fig. 3.5.1 Cargo tank and piping layout, and cargo console room layout

On 19 January 1994, the No. 5 port side and starboard side wing tanks of a tanker were being filled. At that stage, the officer of the watch closed the filling valve to the No. 5 port side wing tank. The result was that cargo oil with a flow rate of 1200 m³/h flowed into the No. 5 starboard side wing tank and an overflow situation occurred (a plume of oil sprayed about five meters into the air from the P/V breaker valve). Because of over-pressure, the tank bulkhead between the No.4 starboard side wing tank and the No. 5 starboard side wing tank ruptured (Fig. 3.5.1(A)).

As long as the alarm is not accepted, it continues to flash on the computer screen, but other audible alarms are OFF without exception. In this example, an alarm that had not been accepted earlier remained, so the audible level alarm did not activate; moreover, the level alarm flashing on the computer screen had very small characters and it could not be seen from the position of the officer of the watch.

In this example, the alarms related to cargo operation controls were not integrated at one location, and the one person in charge found it difficult to monitor all the indicators. Moreover, the tank level display did not correspond directly with the tank number; thus adversely affecting the correct understanding of the situation.

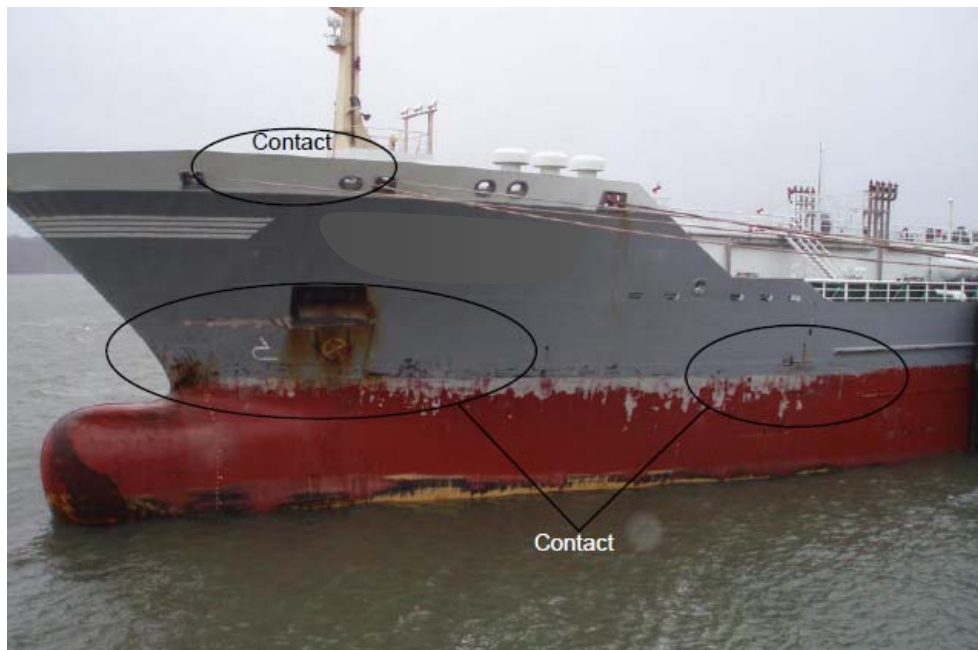
Fig. 3.6.1 Ship that suffered the accident

The control of the podded propulsion system for a product tanker was lost when approaching a jetty and the vessel collided with said jetty. Both the ship and the jetty suffered severe damage as a result of this accident (Fig. 3.6.1). The ship's podded propulsion system was designed so that if the main control system failed, an audio-visual alarm would activate and the system would automatically switch over to a backup system. However, since the ship was navigating at night when the accident occurred, the visible alarms were darkened and the audible alarms were inadequate to attract attention. For this reason, the handing over of control of the podded propulsion system to the backup system was discovered too late and there was not sufficient time to undertake avoidance measures.

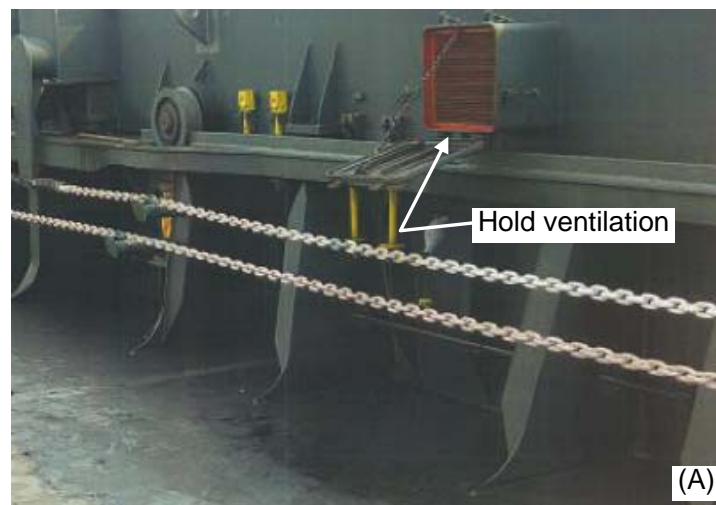
Fig. 3.7.1 Hold vent opening

In a bulk carrier, the ballast water in the No. 6 ballast-cum-cargo hold was de-ballasted, but the vent opening shown in Fig. 3.7.1(A) was not opened. About an hour later, a crew member became aware that the vent opening was closed. During this one-hour period, damage occurred to the hatch coaming and the cross deck, which both became bent because of the negative pressure in the cargo hold. After the accident, the ship's owner decided to display the label "Confirm that all ventilation covers/ manholes are OPEN before starting the ballasting/ de-ballasting operations" on the ballast control console, as shown in Fig. 3.7.1(B).

As design measures, the following may be considered: (1) The label "Confirm that all ventilation covers/ manholes are OPEN before starting the ballasting/ de-ballasting operations" should be displayed on the ballast control console. (2) The de-ballasting procedure, including check for opening the vent opening, should be displayed in bulleted format on the ballast control console. (3) An interlocking mechanism should be provided that ensures ballasting/de-ballasting cannot be carried out when the vent opening is in the closed condition.

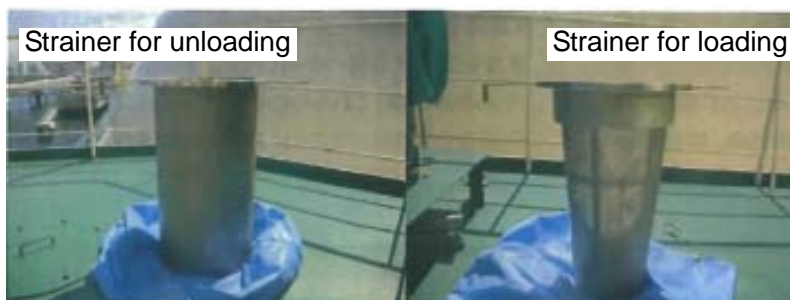
Fig. 3.8.1 Strainers for loading and for unloading

At the subsequent investigation, the direct cause of this accident was found to be the storage of the strainer for loading and the strainer for unloading in wrong storage boxes. That is, the strainer used for loading was stored in the storage box for unloading strainer, and the strainer used for unloading was stored in the storage box for loading strainer. Normally, since only one strainer is taken out at the unloading site, such errors in storage were not anticipated; however, it was found that maintenance work on the relevant strainer storage boxes had been performed about three months prior to this incident. At that stage, all strainers had been removed from the boxes, and it is highly probable that the strainers were replaced in the wrong boxes.

On the other hand, as shown in Fig. 3.8.1, the external appearance of the strainers for loading and unloading do not resemble each other so much that distinguishing one from the other is difficult. However, if the crew member sees only one of the two strainers, it is highly probable that the crew member does not have the knowledge to judge whether it is a strainer for loading or a strainer for unloading. An arrow indicating the direction of flow had been stamped on the handle of the strainer, but there was no name and name tag indicating its application. It is difficult to distinguish whether the strainer is meant for loading or for unloading from the direction of the arrow alone, especially if one is not particularly focused on identifying it.

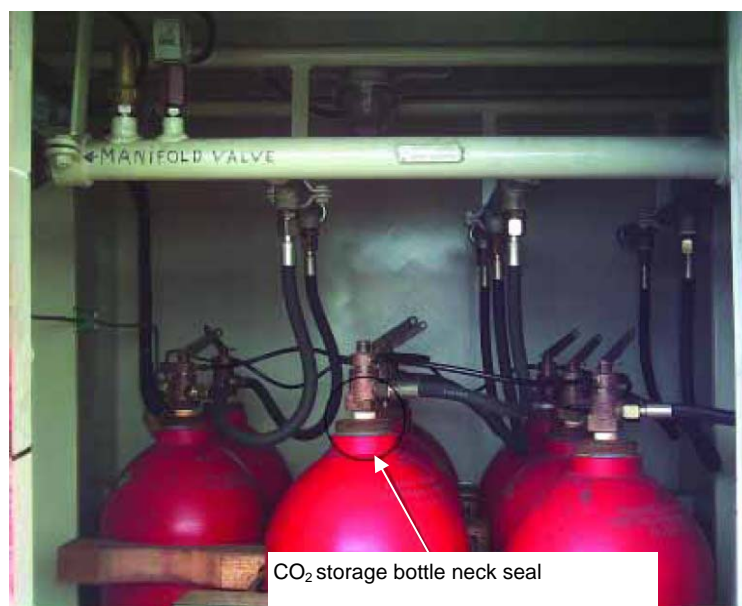
Fig. 3.9.1 CO₂ bottle

The chief engineer of a ship was conducting routine monthly checks of the fixed type carbon dioxide fire fighting systems in the engine room. The sleeve of his arm inadvertently got caught in the pilot CO₂ pilot bottle isolating valve. Unaware of this, the chief engineer had set the isolating valve to the partially open condition. In this condition, he opened the pilot CO₂ bottle pressure gauge isolating valve in order to confirm the pressure of the pilot CO₂ bottle. The activator of the main CO₂ bottle activated, the main CO₂ bottle started becoming pressurized, and CO₂ gas started leaking from the neck seal (Fig. 3.9.1) of one of the bottles. Fortunately, the chief engineer became aware of the CO₂ gas leak and took action, so the leak did not lead to a major accident.

The cause of a piece of equipment becoming activated by mistake as a result of unintentional contact is easy to visualize, but considerations for preventing such occurrences in the design or installation stage are generally inadequate. For important control equipment, it is essential to predict the results of physical contact with the item then formulate and implement adequate preventive measures.

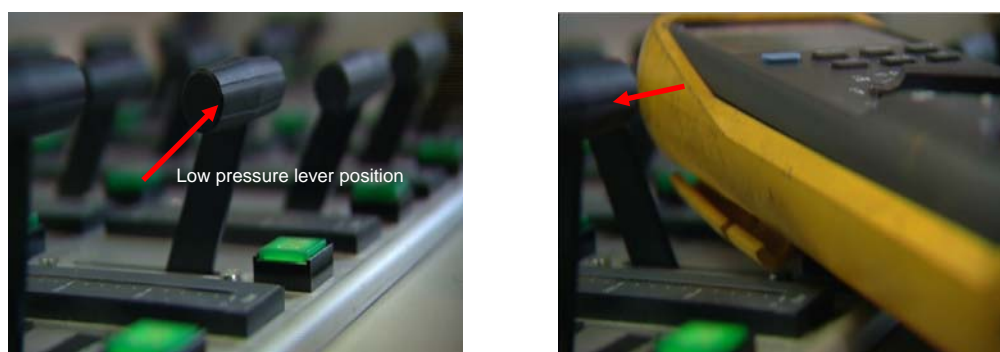
Fig. 3.10.1 Cargo pump pressure control lever

Fig. 3.10.1 shows an unloading pump pressure control lever onboard a chemical tanker. The lever of this control device is slid forward or aft to start/stop the pump and adjust outlet pressure. Based on instructions from shore during unloading work on the ship, the person in charge lowered the pump pressure tentatively, but another crew member accidentally switched the lever to high pressure when he placed a measuring instrument on the panel. The result was that the shore unloading pipe ruptured, cargo with chemical substances spilled, and enormous cost was incurred in cleaning up the spill.

This example is similar to example 3.9. The cause was the unintentional movement of a lever that led to a mistake in the operation of equipment. Although the cause may be considered simple, adequate precautions are necessary.

As design measures, the following may be considered: (1) Protect the pump pressure control lever by a cover or some other physical barrier. (2) Provide adequate resistance to operate the pump pressure control lever. By doing so, even unintentional light contact will not cause the lever to be moved (see ASTM F1166-07 5.1.9). (3) Provide a locking mechanism for the pump pressure control lever.

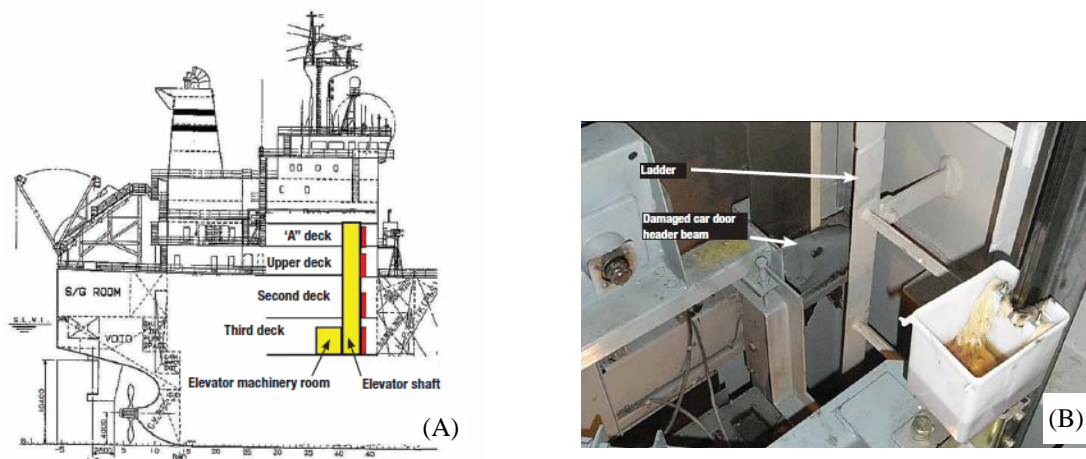
Fig. 3.12.1 Elevator and vertical ladder in the elevator shaft

To perform repairs, the second engineer and the electrician firstly confirmed that they had placed the sign "Do not operate" at the entrance of the elevator on all the floors, and then went to the second deck and opened the elevator door. After both persons finished their examinations, the electrician stepped on the ladder (Figure 3.12.1(B) on the right) in the elevator shaft, and told the second engineer to close the doors.

However, immediately after the doors closed, the elevator car started traveling upward; the electrician was trapped between the elevator car and the ladder, and resulting in his death.

The elevator car travelled upward because somebody had pushed the button; this was confirmed from the records of the microprocessor control unit. That is, somebody had ignored or had overlooked the "Do not operate" sign, and had pressed the button.

Reports of accidents such as carelessly removing the stopped condition of an elevator by using the emergency stop button have been reported elsewhere, as well. Foolproof measures are necessary because this type of accident can have disastrous results.

As design measures, the following may be considered: (1) Display of signs indicating "Under Repair/Inspection" should always be placed at the call button on each floor when repair/inspection is being performed. (2) Covers should be installed on call buttons to prevent incorrect operation (see ASTM F1166-07 5.1.9 and Fig. 3.12.2). (3) Provide a stop button especially for maintenance and inspection. The design should be such that the stop reset of this button can be made only by the operator who has stopped the operation.

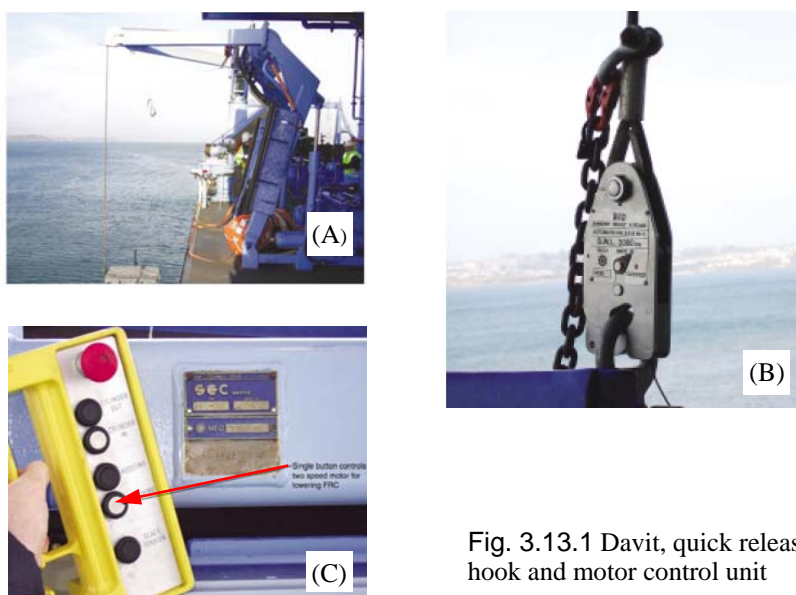
Fig. 3.13.1 Davit, quick release hook and motor control unit

The slow speed operation of the winch was 0.6 m/s and the high speed was 1.3 m/s; these two modes were realized by a two-speed motor. The motor speed was controlled by one push button (Fig. 3.13.1(C)); when this button was partially depressed, low speed was selected; when fully depressed, high speed was selected.

Investigation later revealed that when the davit juddered, the hook changed to the off-load mode and automatically released the boat. Moreover, when the winch motor stopped (button released) from the high-speed condition (fully depressed), the davit assembly juddered considerably. This was also confirmed from tests. It was considered probable that the winch operator had depressed the button fully so the FRC was lowered in the high speed condition and then stopped. Therefore, the davit juddered considerably, and it is thought that this movement in the davit arm could have been sufficient to cause the off-load release hook to open automatically.

This accident is presumed to have occurred because of the change from high speed to an abrupt stop, causing vibrations which resulted in the off-load condition. It is also concluded that an operating mode not originally anticipated occurred because of the incorrect operation of the push button. A push button having multiple functions depending on how far the button is depressed is not recommended because buttons with such specifications are likely to cause errors.

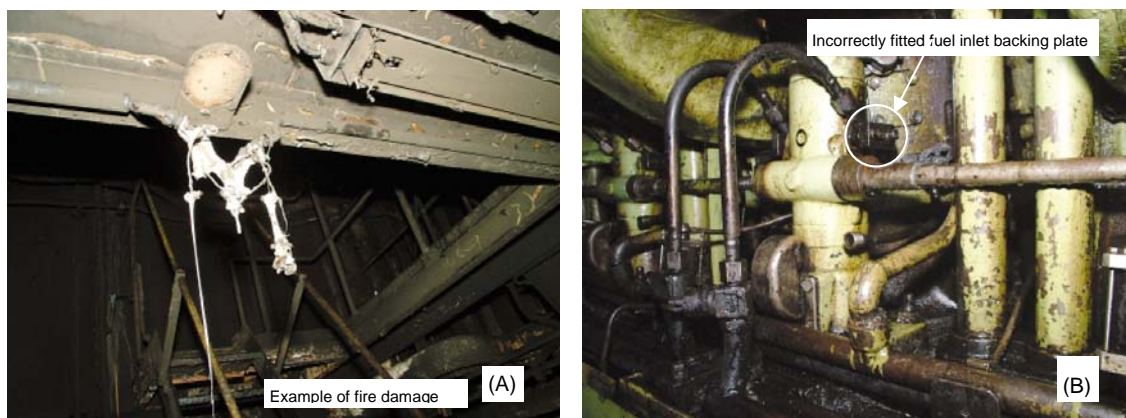
Fig. 3.14.1 Burnt-out engine room and mistakenly fitted securing plate for securing fuel inlet pipe

An engine room fire broke out onboard a cargo ship. The fire caused major damage to the engine room machinery and equipment (Fig. 3.14.1(A)). The cause of the fire was determined to be the loosening and displacement of a securing plate for a main engine fuel pump inlet pipe. The fuel pipe became displaced because of this, and fuel at a pressure of 5 bars and a temperature of 100°C spewed out, came into contact with the surface of an exhaust gas pipe at a high temperature, and ignited.

Investigation after the accident revealed that the fuel inlet pipe securing plate was incorrectly fitted – the plate was reversed. (See Fig. 3.14.1(B)). Owing to this mistake, the cap screws were only screwed into the fuel pump block by 2 and 1/2 turns, as opposed to 8 and 1/2 turns when correctly fitted. It is likely that the securing plate worked loose due to vibration and became displaced.

The fuel pump had been replaced five months earlier; during this replacement, it is likely that the plate was incorrectly fitted in the reversed direction.

Fitting the wrong parts or fitting parts in the wrong direction or wrong position frequently occurs during the replacement or restoration of opened-up equipment or machinery. It is likely that in this accident, the front side of the securing plate was counterbored (if done correctly), and screws could be tightened up to 8 turns. However, since the front and rear sides were reversed, the number of turns of the screw became smaller by an amount corresponding to the depth of the counterbored part. To prevent similar accidents, measures are necessary to identify parts and to confirm their correct position and direction. It is also important to design parts with shapes so that they cannot be fitted in the reverse direction.

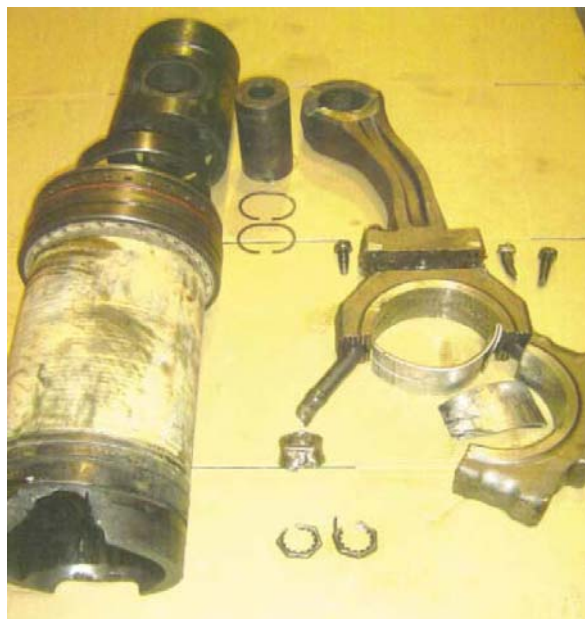
Fig. 3.15.1 Damaged piston liner and connecting rod

After extinguishing the fire, damage was found in the No. 6 cylinder unit, as shown in Fig. 3.15.1. This was a so called "breakdown of the connecting rod together with the crankcase" accident.

The cause of the accident was as follows: since the lower side shell of the crankpin bearing was fitted on the upper side and the upper side shell was fitted on the lower side, the supply of lubricating oil to the crankpin bearing and the supply of cooling oil to the lower part of the piston were prevented. This caused the piston to heat up, and become stuck to the cylinder liner. In this condition, the crankshaft continued to rotate, so the bolts at the big end of the connecting rod fractured, resulting in the breakdown of the connecting rod together with the crankcase.

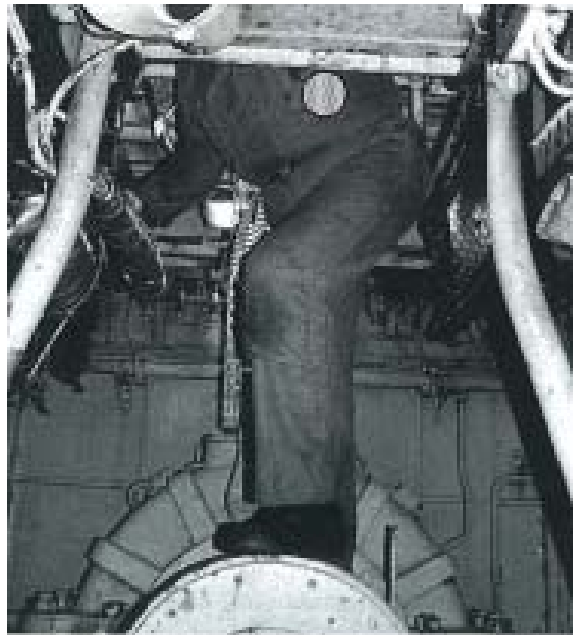
Fig. 3.16.1 Poor installed location of valve

In order to manually open the air starting valve of the main engine onboard a merchant ship, the operator had to operate the valve by standing on the electric motor of the turning gear, as shown in Fig. 3.16.1.

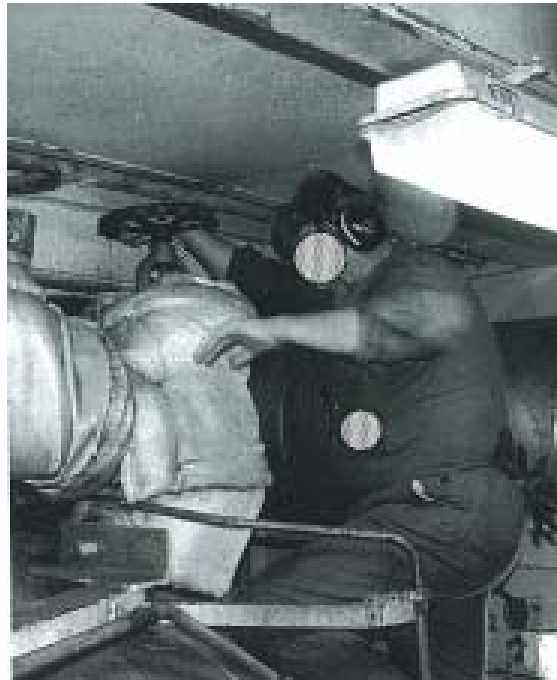
Fig. 3.17.1 Poor installed direction of valve

The main steam outlet valve onboard a merchant ship had to be operated by the operator climbing a ladder and operating it from an unstable position, as shown in Fig. 3.17.1.

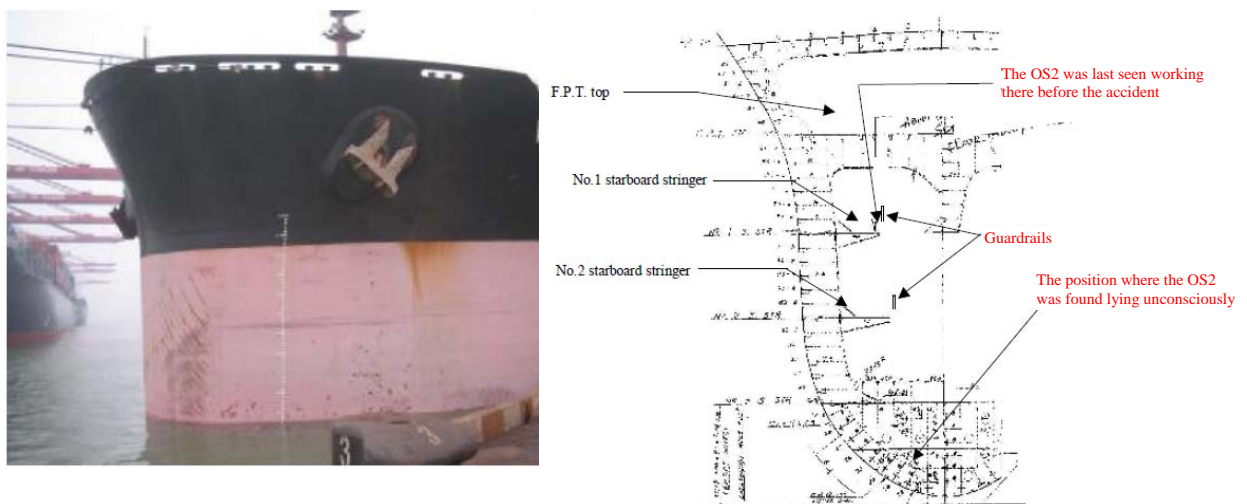
Fig. 3.18.1 Fall into a tank

On 9 March 2006, three crew members of a bulk carrier were working inside the forepeak tank. At around 1545 hours, one of the crew members, while cleaning the end of the stringer, fell to the bottom of the FPT and was killed (see Fig. 3.18.1). It is likely that said crew member slipped and fell over the guardrail to the bottom of the tank. The contributing factors of the accident may include the following: (a) the other two crew members were using the portable light at the time of the accident, so the surroundings may have been dark; (b) the ship was navigating at full speed, so the pitching and rolling motions may have been excessive; (c) the floor surface of the stringer was wet and slippery.

Problems in safety management, such as the inadequate illumination of tanks, are evident in this accident. However, the height of the guardrails in the tank was also inadequate, and did not prevent the fall. Considering this accident, it is important to install guard rails with adequate height at overhead locations even if such locations are rarely accessed by workers (see ASTM F1166-07 11.13.3).

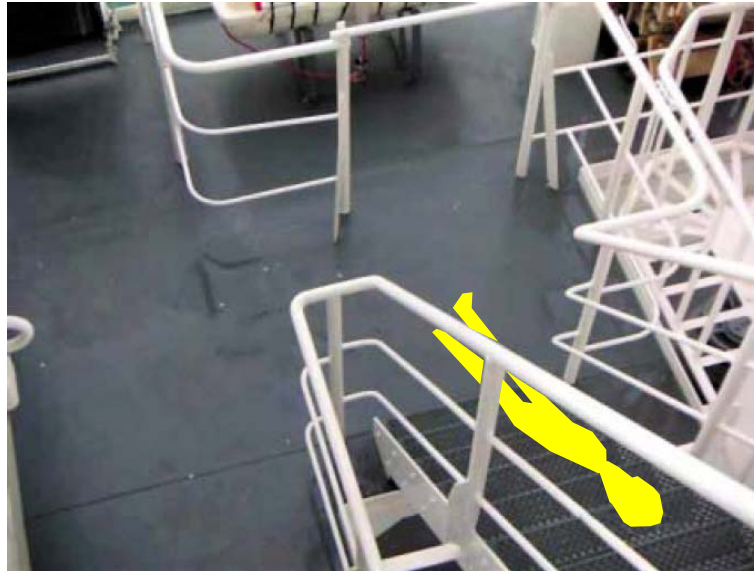
Fig. 3.19.1 Fall on deck

To repair the solenoid coil of the brokendown starboard side crane of a container ship, the electrician went down the ladder shown in Fig. 3.19.1. The deck was wet due to rain and, therefore, slippery. The electrician slipped and fell on to his back, striking his head. An hour later, he was pronounced dead.
