SAFETY STUDY 1/2001

**REVIEW OF
LIFEBOAT AND LAUNCHING SYSTEMS'
ACCIDENTS**

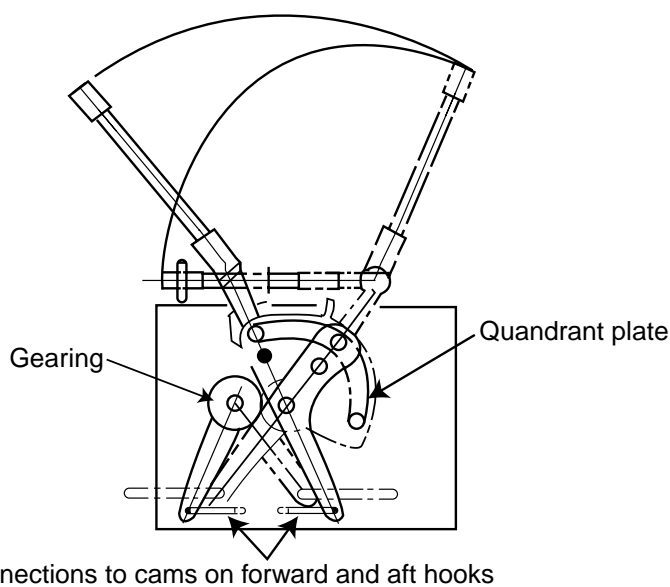
Figure 2

Analysis of a number of accidents reveals that premature hook release has often been caused by the failure to re-set it correctly when the lifeboat was being recovered from its previous launching. This shortcoming stems from a lack of understanding of the mechanism involved, inadequate training and poor maintenance. Once the hook has been incorrectly reset, spontaneous release is possible at any time before the lifeboat is next put in the water **(see Figures 2 and 3)**.

This is compounded by the complexity of the mechanism and operating instructions that are difficult to understand. The diagram, showing the important features of resetting the mechanism, is complicated and makes it necessary to be able to clearly see the actual mechanism to understand its workings. However, viewing the mechanism is difficult, making understanding of the diagram difficult. Other material in the manufacturer's instruction manual was of little help in this task.

The central operating lever is placed adjacent to the coxswain's position, often in such a fashion that the gearing, quadrant and very important safety pin cannot be viewed easily. Indeed it is often impossible for the user to obtain the same view of the mechanism as it is shown on the instruction panel, he can see it only from above, making the important components difficult to identify. This problem is aggravated by these parts being below the bottom boards of the boat in an area of darkness.

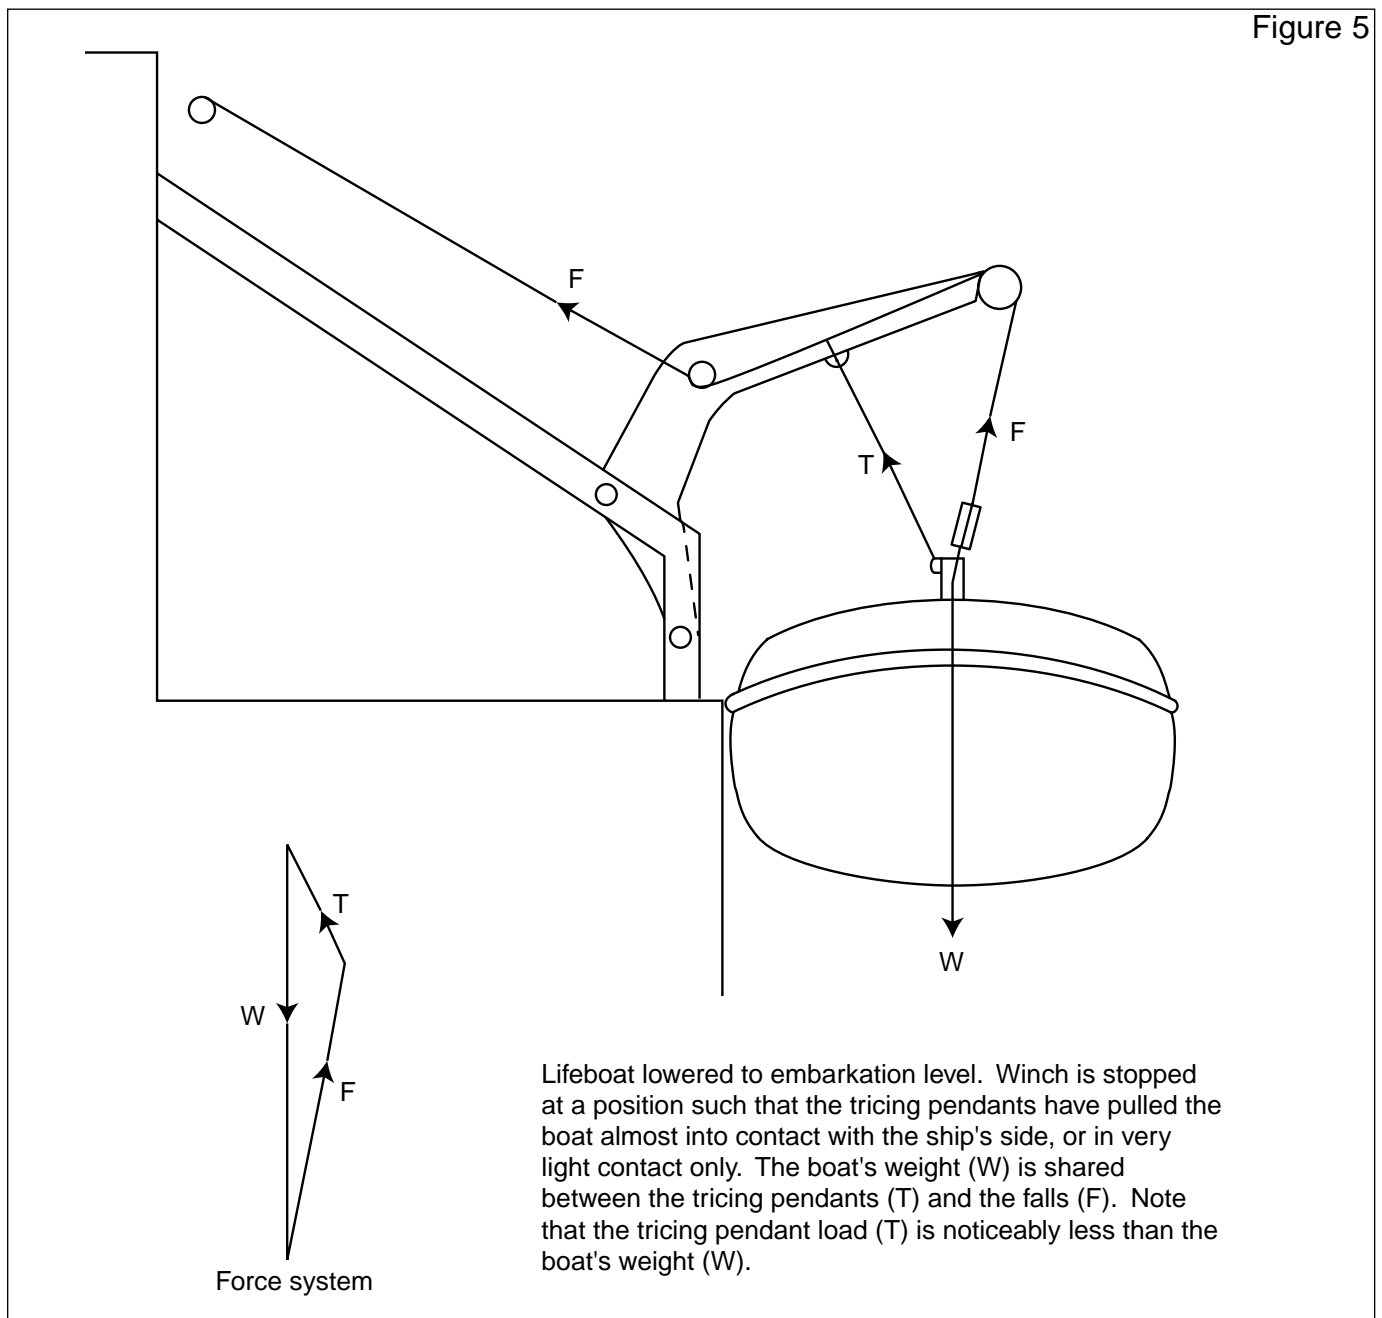
Figure 6

Launching procedures call for the lifeboat to be lowered to embarkation level while the tricing pennants pull it into the side of the vessel (see Figure 5). Once at the correct level, bousing tackles are secured between the forward and aft lower blocks and the ship (see Figure 6). When tightened they take over the function of the tricing pennants, which are then disconnected.

Above diagram shows the forces acting on a davit arm with the boat properly bowsed in with the bowsing tackle horizontal. This is the condition shown in Figure 6. The forces in the lower and back falls have been added to give the resultant wire load. The only other significant forces acting on the arm are the top and bottom roller forces.
